Project Name:	Mountain Valley Pipeline	Inspector:	Matthew Grant		
Inspection Date:	Monday, November 30, 2020	Project Contact:	Brian Clauto		
Spread I: Franklin	MP248.2-248.3 ATWS1248, 1410, 1250, 1249 AR FR 291, 292	Weather:	Wet

## FIELD INSPECTION PHOTO LOG

**Project Name:** Mountain Valley Pipeline

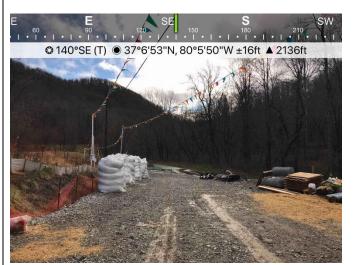
Figure 2: ATWS 1250 ECD's are in place.
